Mobile Intel® Pentium® 4 Processor-M

Specification Update

September 2003

Document Number: **250721-018**

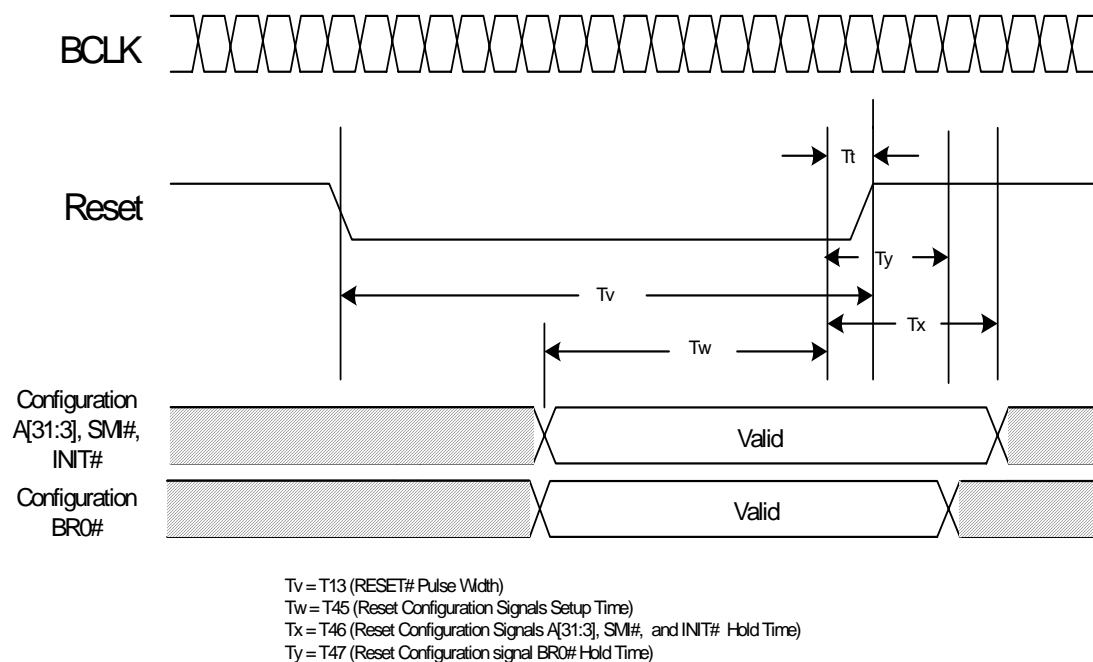
Figure 13. System Bus Reset and Configuration Timings

The BR0# maximum hold time has changed to 2 BCLKs. This change will be shown in the “System Bus AC Specifications (Reset Conditions)” table and “System Bus Reset and Configuration Timings” figure of the *Mobile Intel® Pentium® 4 Processor - M Datasheet*. This change will be incorporated in the next revision of the datasheet.

The following figure will be modified to reflect this change:
